# Case studies

Real ThinkSystem problem determination and troubleshooting case examples

Lenovo

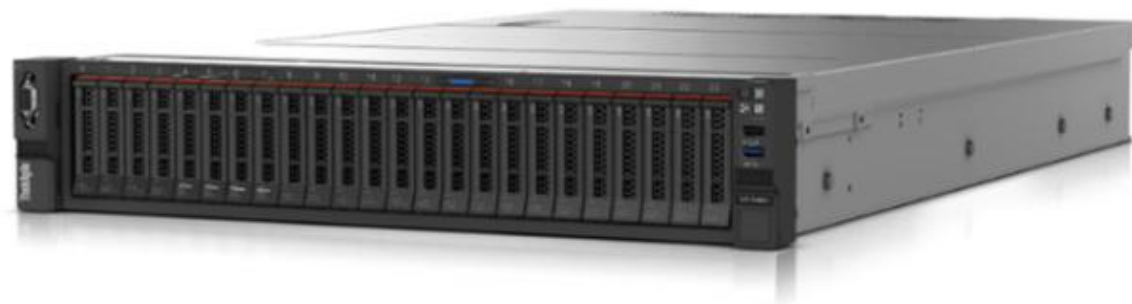
- A user reported a failed drive – one of the drives could not be recognized by the OS (EXSi)
- The drive was running in JBOD mode
- The user's system was a ThinkAgile VX machine type 7Y94 (the hardware is based on the ThinkSystem SR650)
- VMware vSAN reported the issue, not XCC

**Suggested action:** Follow the instructions in the technical tip. Use commands to locate the failed drive and then replace it. If the problem remains, escalate the problem to the VMware support team.

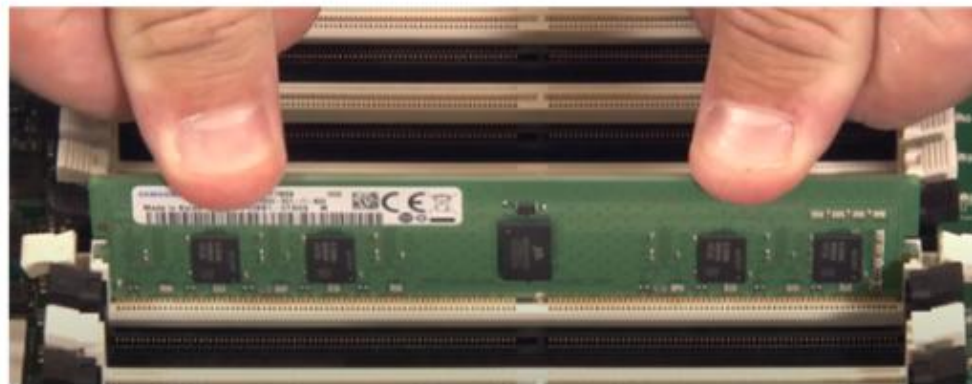
- A user reported a DIMM error issue: System DIMM 17 had failed
- The user's system was a ThinkAgile HX machine type 7X83 (the hardware is based on the ThinkSystem SR630)
- XCC reported the failed DIMM

**Suggested Action:** Do not replace any hardware. Ask the user to go to **UEFI System Settings → Operating Modes** and change the settings to match the following values.

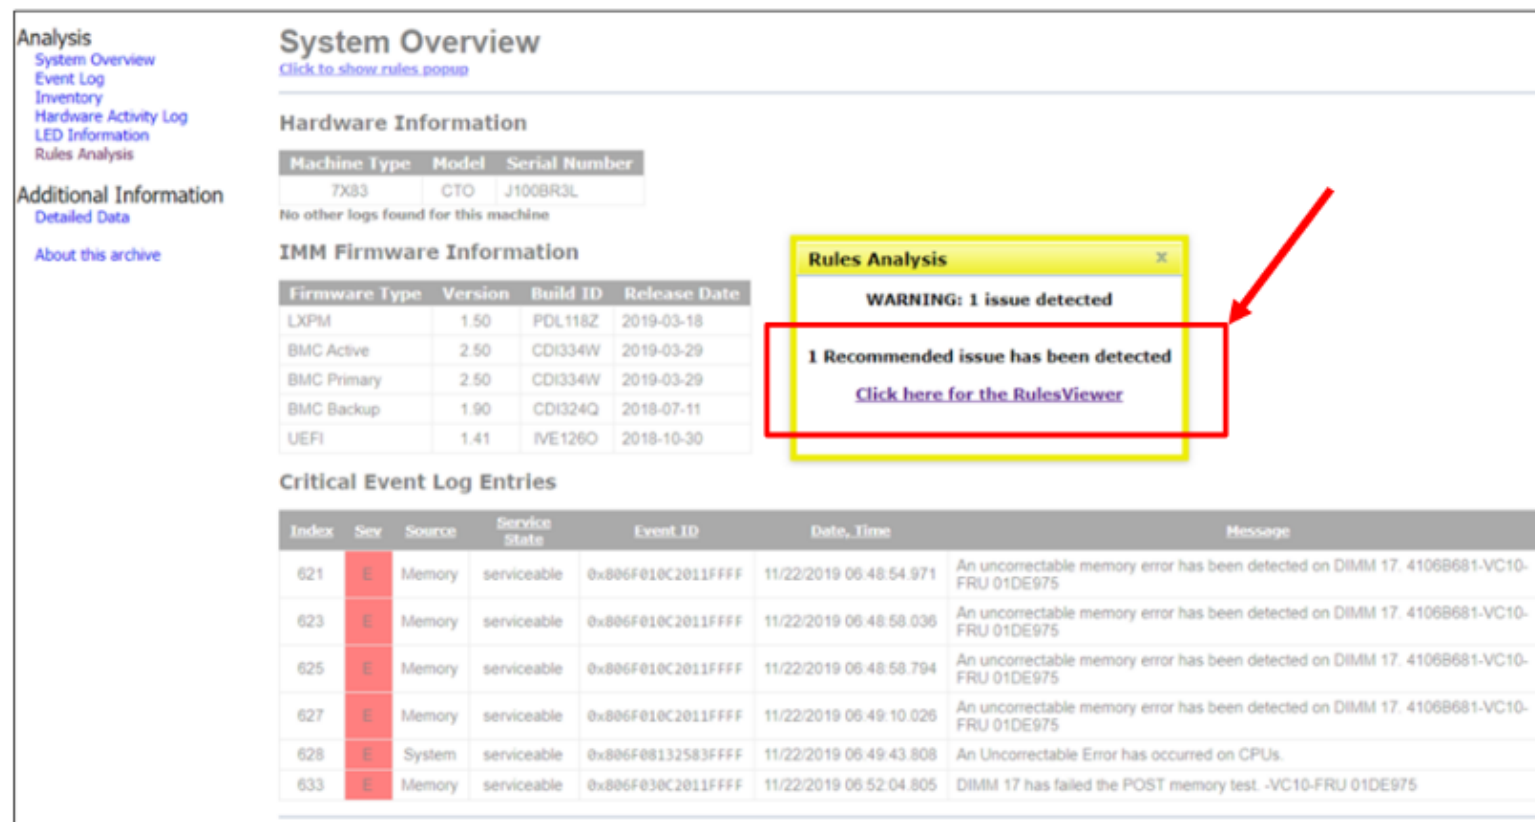
The DIMM 17 and CPU errors are displayed in the log parsing results under **Critical Event Log Entries**. A rules analysis result was also available.

Rules analysis detected that the system UEFI setting did not match the recommended UEFI settings. Note that as this is a solution-level system, all UEFI settings must match the Lenovo manufacturing settings or there might be unexpected errors.

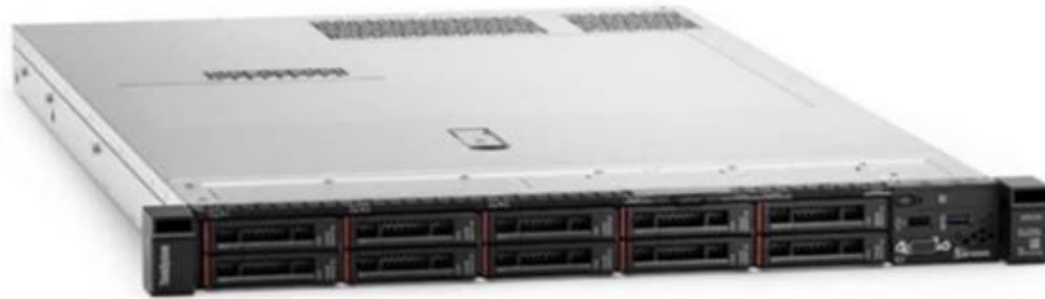
- A user reported that their system could not power on after power cycling
- The user could still access XCC where they found a sensor ME error message
- The user's system was a ThinkAgile HX machine type 7X83 (the hardware is based on the ThinkSystem SR630)

Rules analysis suggested that the system was failing to start with ME in critical state. The user was referred to technical tip [HT504864](#) for more information.

**Suggested action:** Follow the technical tip [HT504864](#) solution to update the system XCC firmware.

It is recommended to have a delay of over eight (8) seconds between each power cycle.

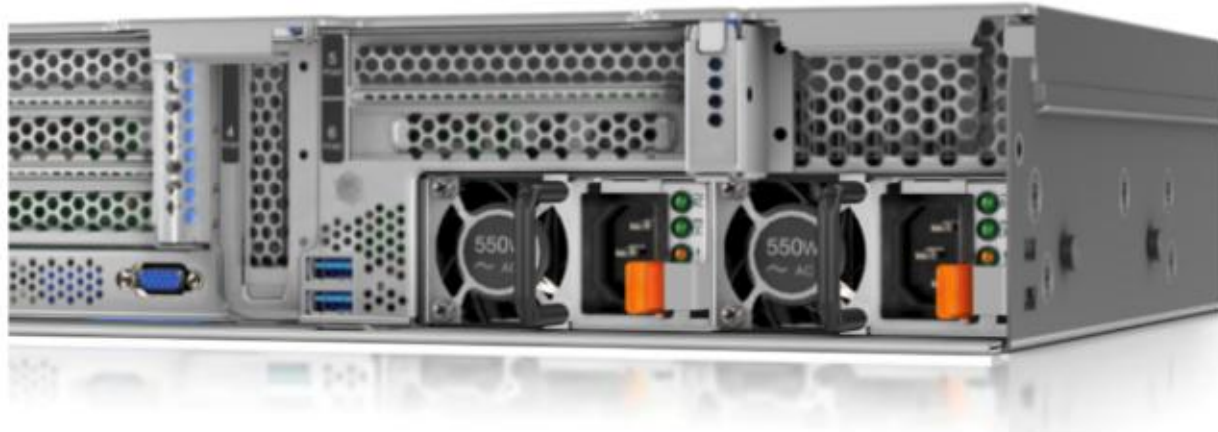
- A user said XCC reported a failed PSU, but the PSU returned to a normal status without any service actions. This happened multiple times.
- The user's system was a ThinkSystem SR590 type 7X99
- The user said this issue happened multiple times on other SR590 servers in their data center

- The user was asked to collect the log.
- After parsing the log, a Power Supply 1 Failed message was displayed.
- There were multiple PSU1 failure and transitioned from normal to non-critical state warning event logs
- Rules analysis was not available in the log parsing results.

- Follow the solution in the tip to update the PSU firmware, or replace the PSU.
- If the problem still exists, escalate the problem to the next level of support.
