Problem determination and troubleshooting

System event logs in BIOS, POST beeps, and LXPM diagnostics

Problem determination and troubleshooting overview

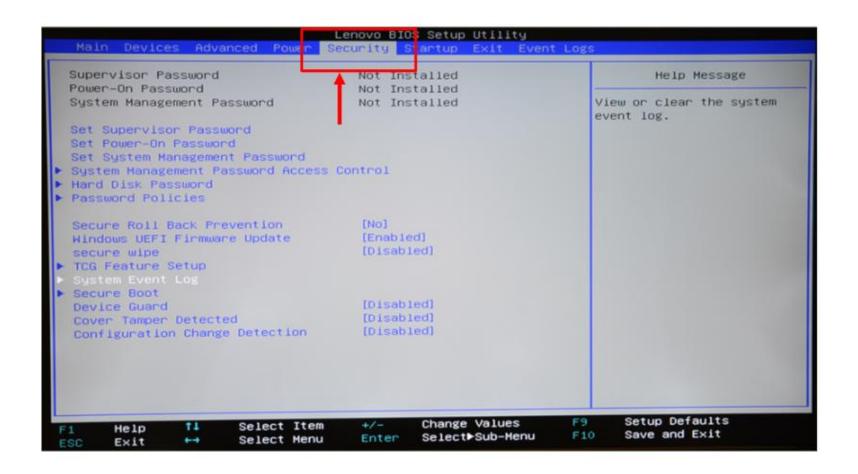
Select Security.

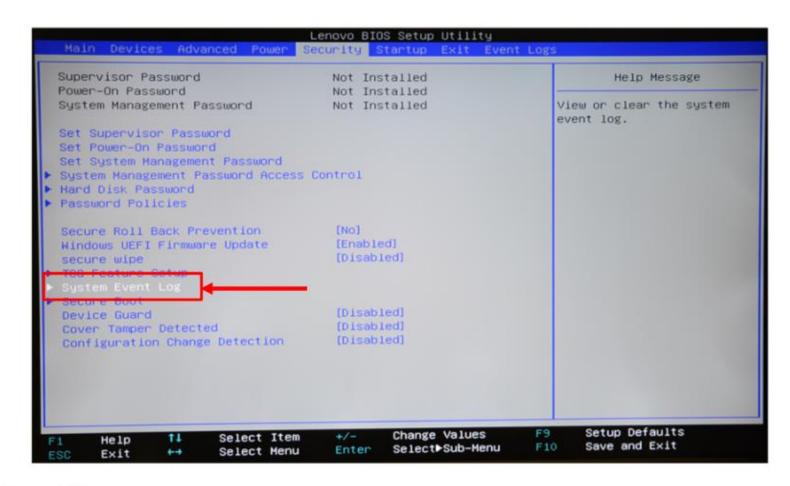
Select System Event Log.

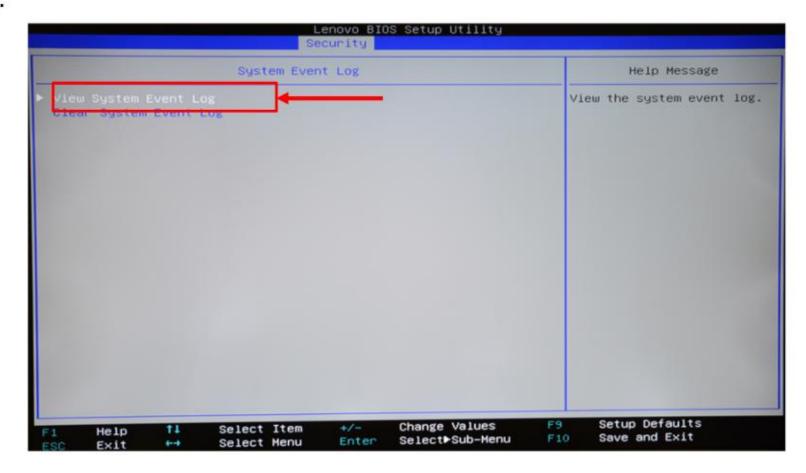
Select View System Event Log.

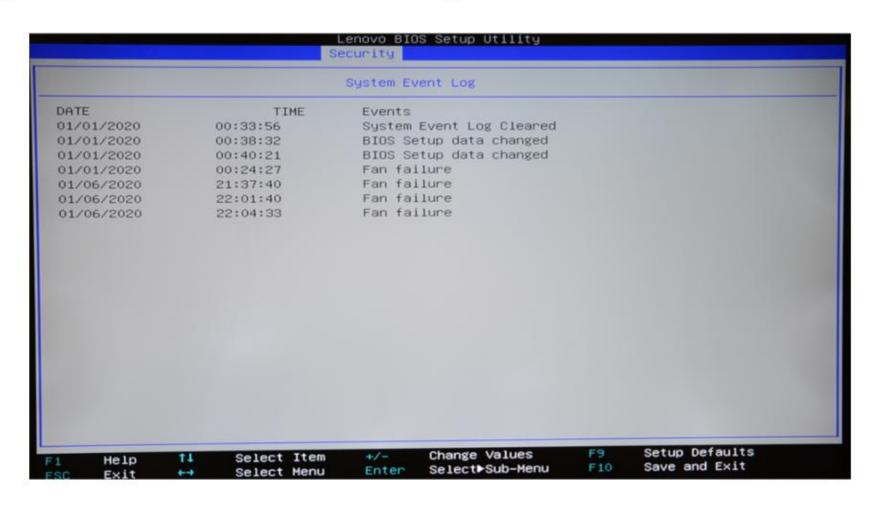
Check the event logs.

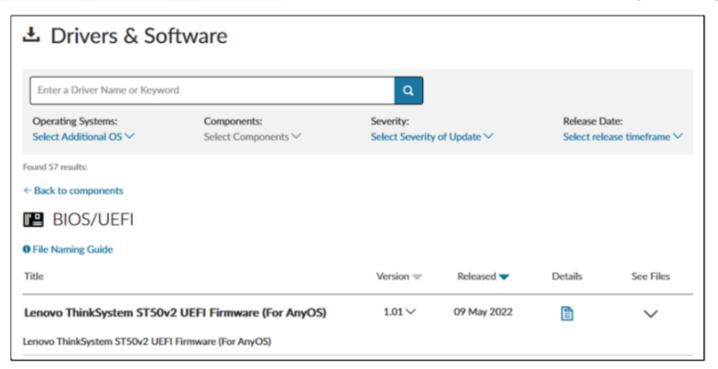
Step 1: Go to

https://datacentersupport.lenovo.com/tw/en/products/servers/thinksystem/st50v2/downloads/driver-list/component?name=BIOS%2FUEFI and download the firmware package.

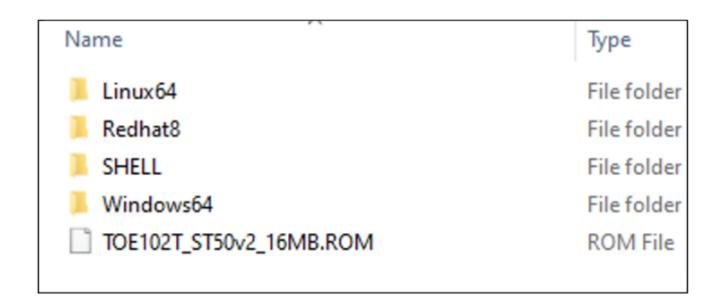
Step 2: Unzip the utility. If you are using a USB drive to upgrade the firmware, copy all the files to the root directory of the USB drive. If you are working within an OS environment, open the corresponding directory.

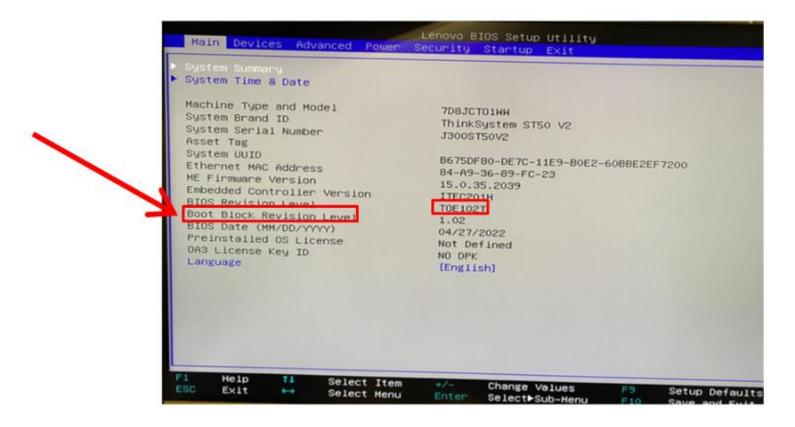
Step 4: After restarting the server, users can check the BIOS revision level in the BIOS SETUP menu.

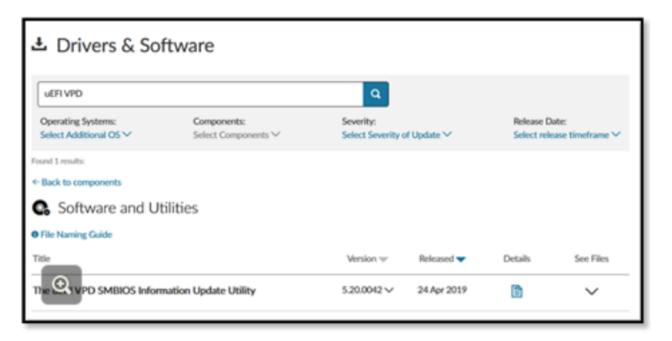
- Click this <u>link</u> and select Software and Utilities. Download The uEFI VPD SMBIOS Information Update Utility.
- Field engineers can also download the utility from the Lenovo internal OSS website (search for ticket number 124770).

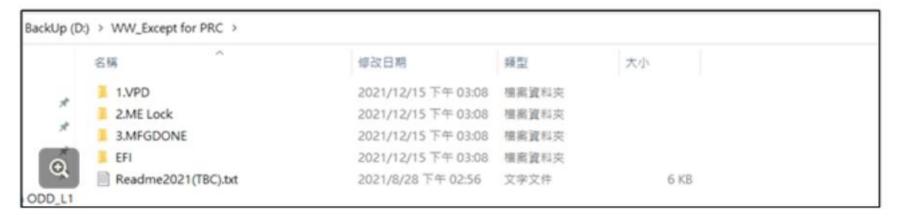
Copy all the files to the USB disk root folder.

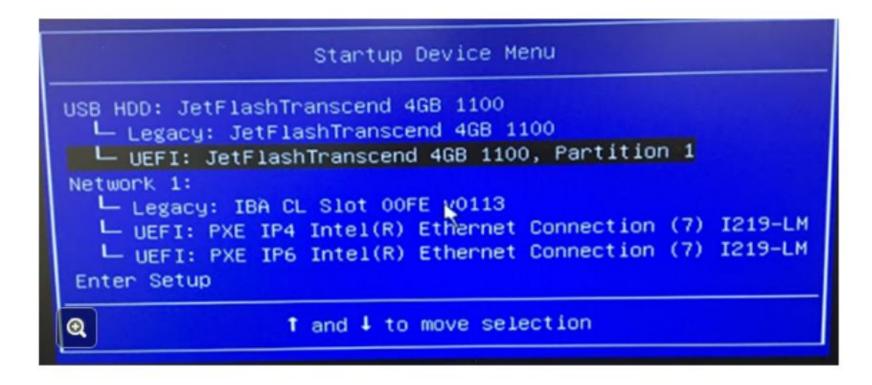
Insert the USB disk into the server, and then boot from the USB disk by pressing F12 during the boot process.
