# Case studies

Real ThinkSystem problem determination and troubleshooting case examples

Lenovo

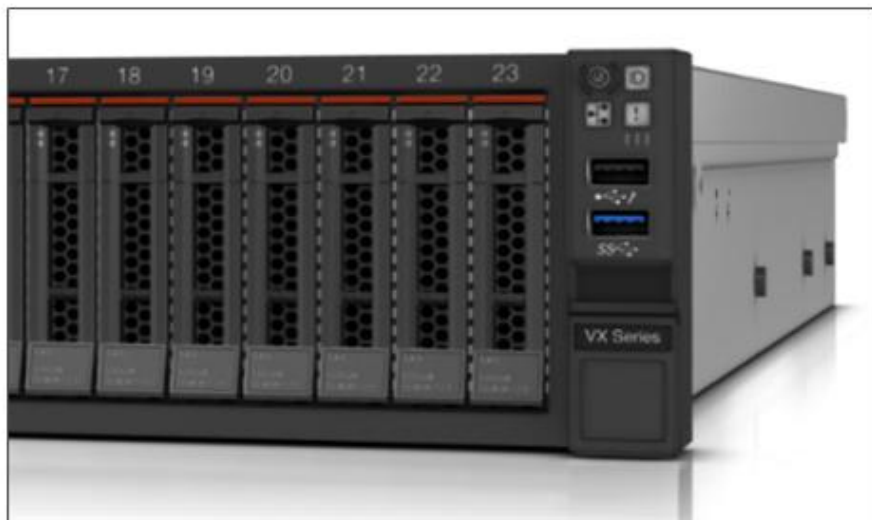
- The user was asked to check the system LEDs, and they confirmed that no system error or HDD error LEDs were lit
- The user was asked to check XCC again, and they confirmed that there were no hardware error or warning messages

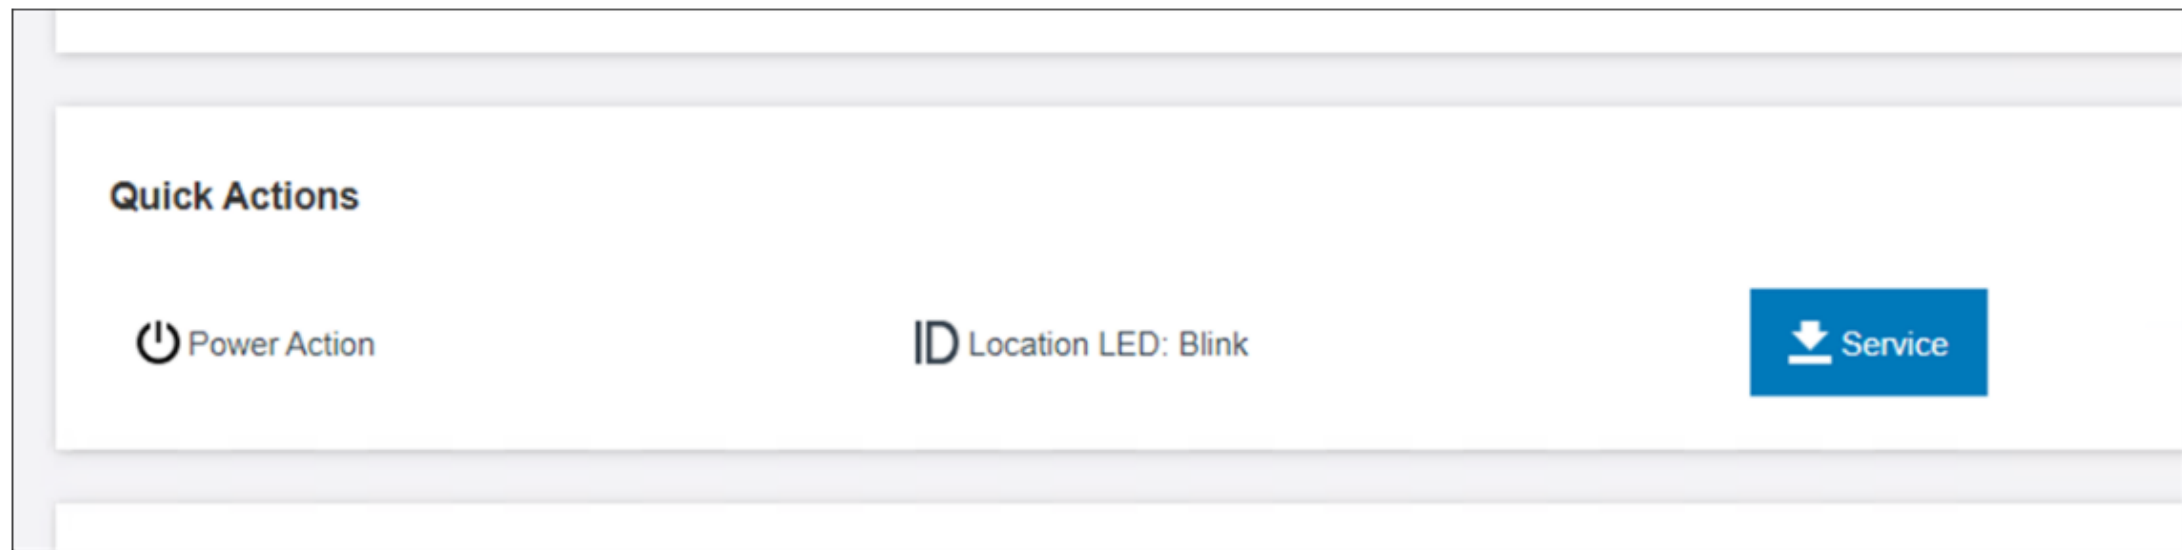
The user was asked to use XCC to collect service data and then upload the service data to Lenovo Systems Care. Note that in this case, the system was running the EXSi OS, so the user could not use OneCLI to collect the FFDC log.
