Problem determination and troubleshooting

Known issues

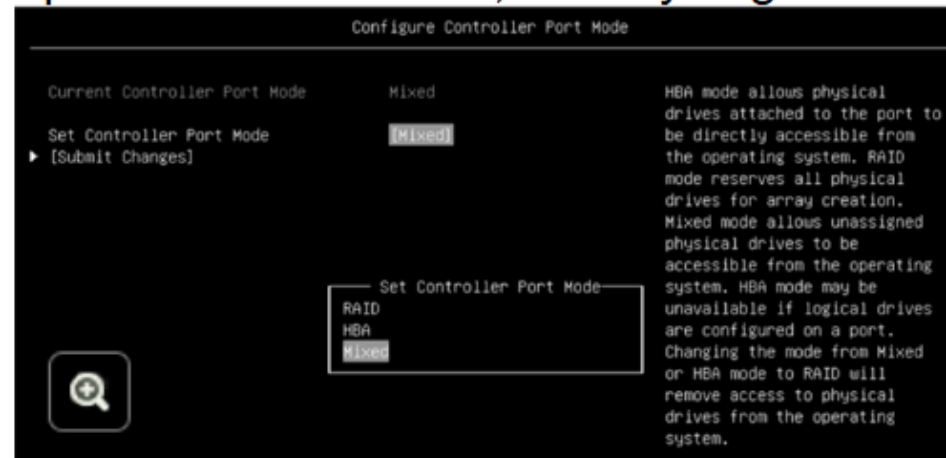
Symptom: Drives/arrays not seen by OS - continued

- If the drives are not seen by the controller, check SAS cable connections, backplane power cable connections, and so on.
- If the drives are seen by the controller, check whether the user changed the mode that the controller or connectors are in.
 - Mixed Mode vs HBA Mode vs RAID mode
 - The new Lenovo HBA/RAID adapters Controller Port Mode default to Mixed Mode, meaning that users can use drives both inside or outside of RAID volumes / virtual drives
 - RAID Mode does not support drives outside of a RAID volume (HBA drives)
 - HBA Mode does not support RAID
 - Modes can be set on a per-connector basis, so they might not be the same for all drives
